August 12, 2019

Project to Beta-Test and Validate the Anzai Nano-Bubble Oxygen/Ozone Technology's Ability to Remediate Blue-Green Algae in Ponds and Lakes

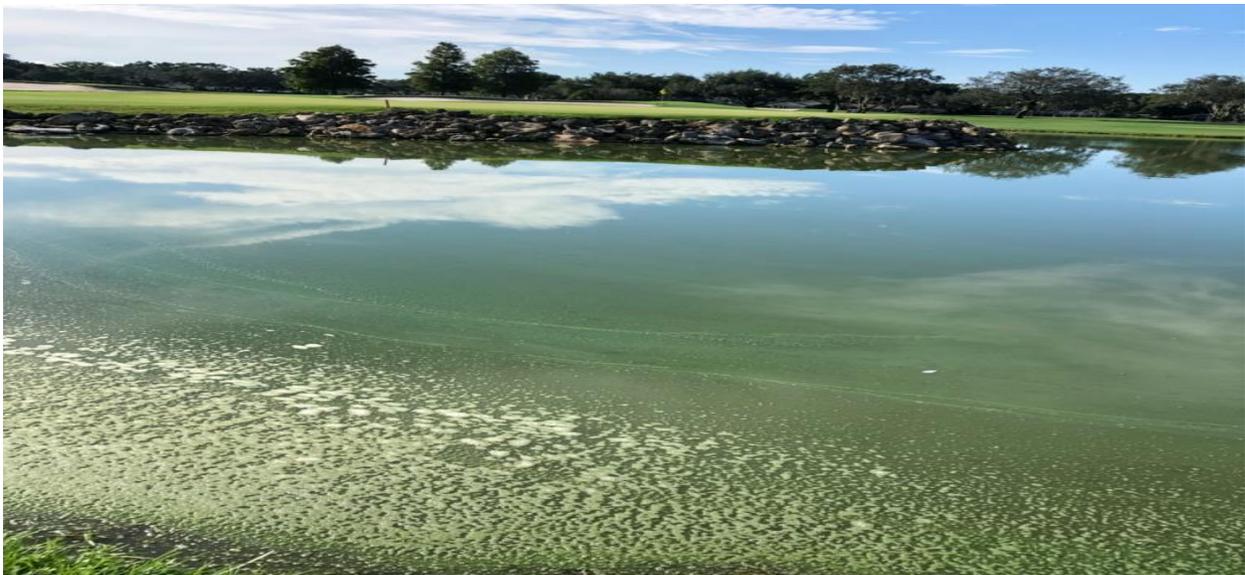
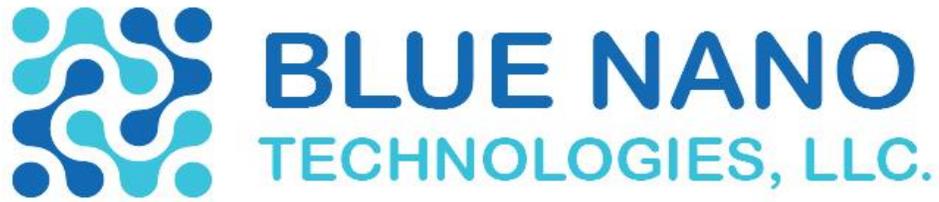
The NBOT system was deployed on the east side of the pond and operated using a diesel-powered 3-Phase generator consuming approximately 21 kWh for the 67.5 hours it was operated during this period.

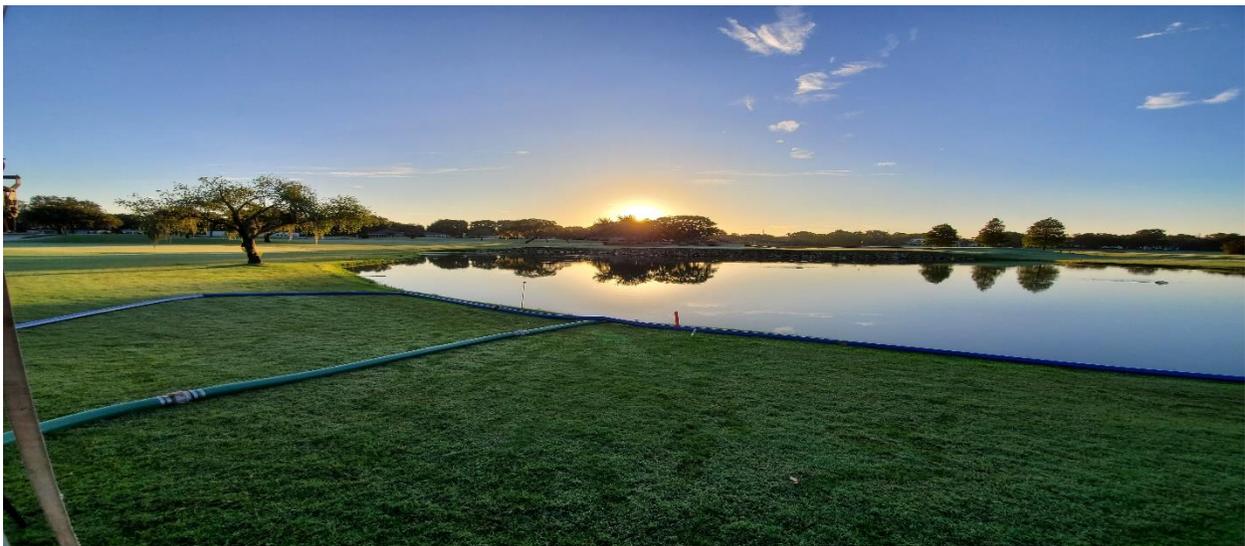
The NBOT system inlet suction hose was connected to a skid resting close to the bottom of the pond. This skid has been specially designed to keep debris and aquatic species from being suctioned into the water treatment system. This was the first time this suction inlet system was deployed, and it worked very well. Also, on the outlet side of the NBOT system, a new design was tested that consisted of a 4-hose manifold allowing broader and even distribution of the oxygen/ozone nano-bubbles throughout the pond. These two specific designs required more work in the setup phase, however observations proved that these applications worked very well.

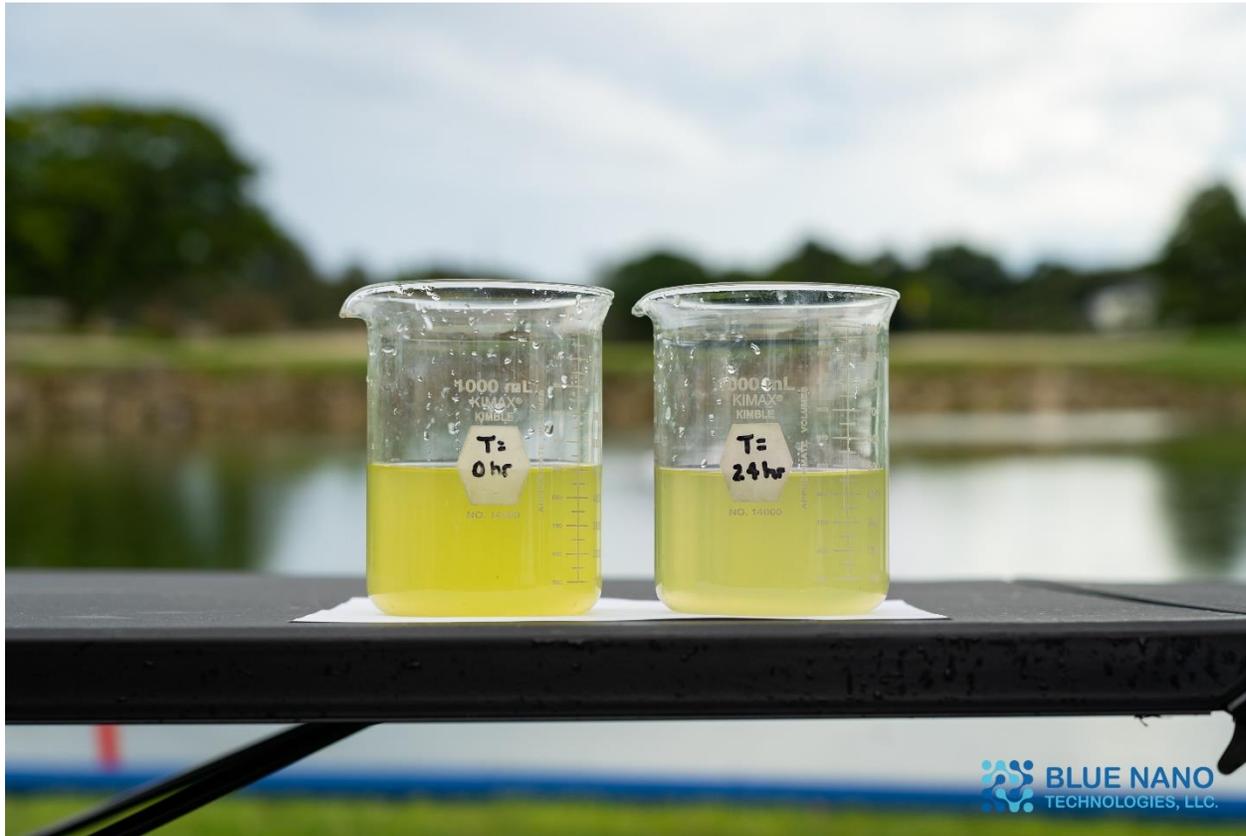
T= 0 hours to T= 24 hours of treatment:

Regarding the clarity of the pond, the algae load in the water was significantly reduced creating greater clarity in the water as shown in the beaker tests below. Also, attached are graphs showing the field data which reflect improvement in DO and ORP during the pond remediation.

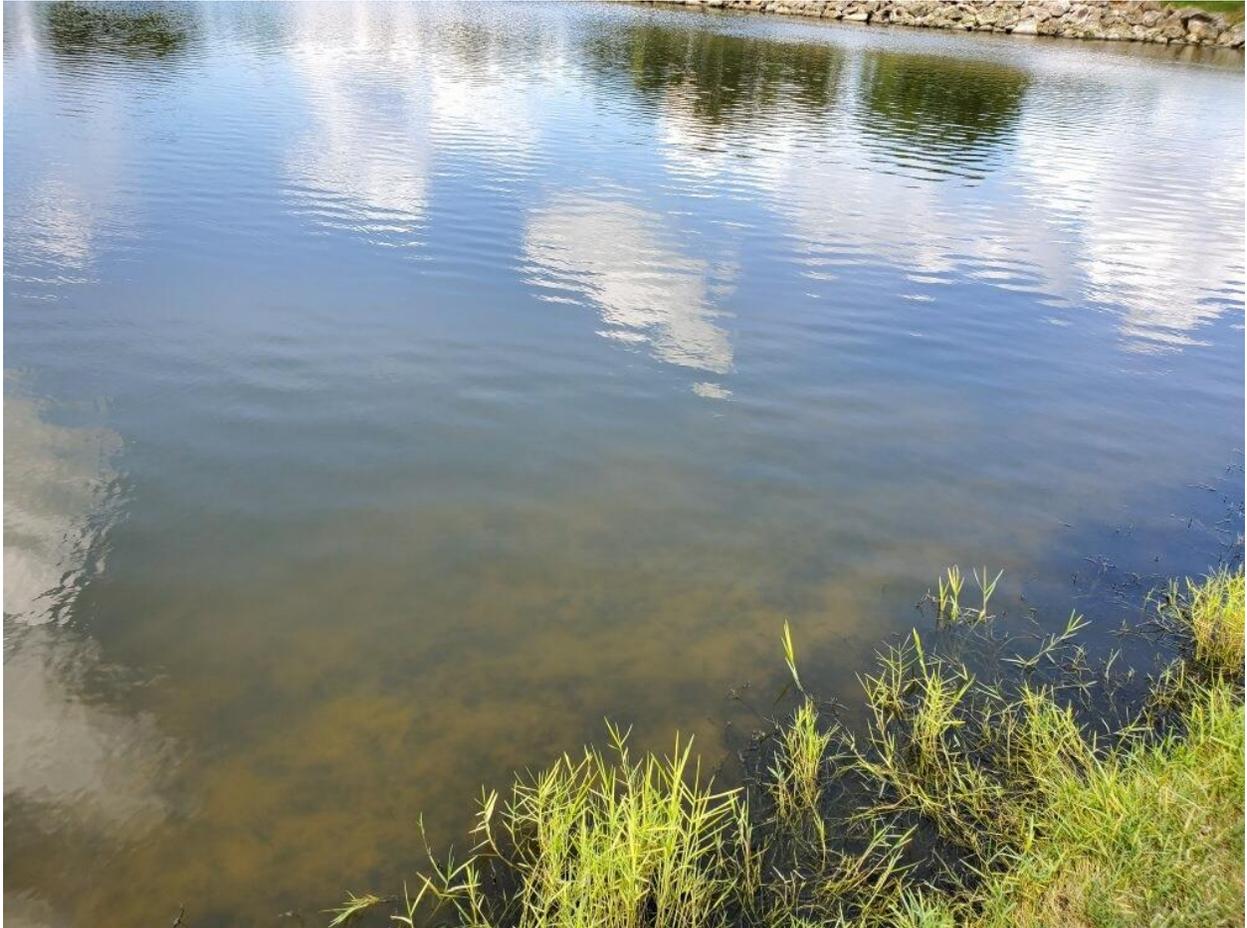
T = 0 hours to T = 14 days after treatment:

One week following the NBOT treatment, samples were taken from the pond in four locations and DO readings were observed to be at 10 mg/L (ppm) which was still almost twice the original level prior to the NBOT treatment. Two weeks following the tests the water clarity was still greatly improved.

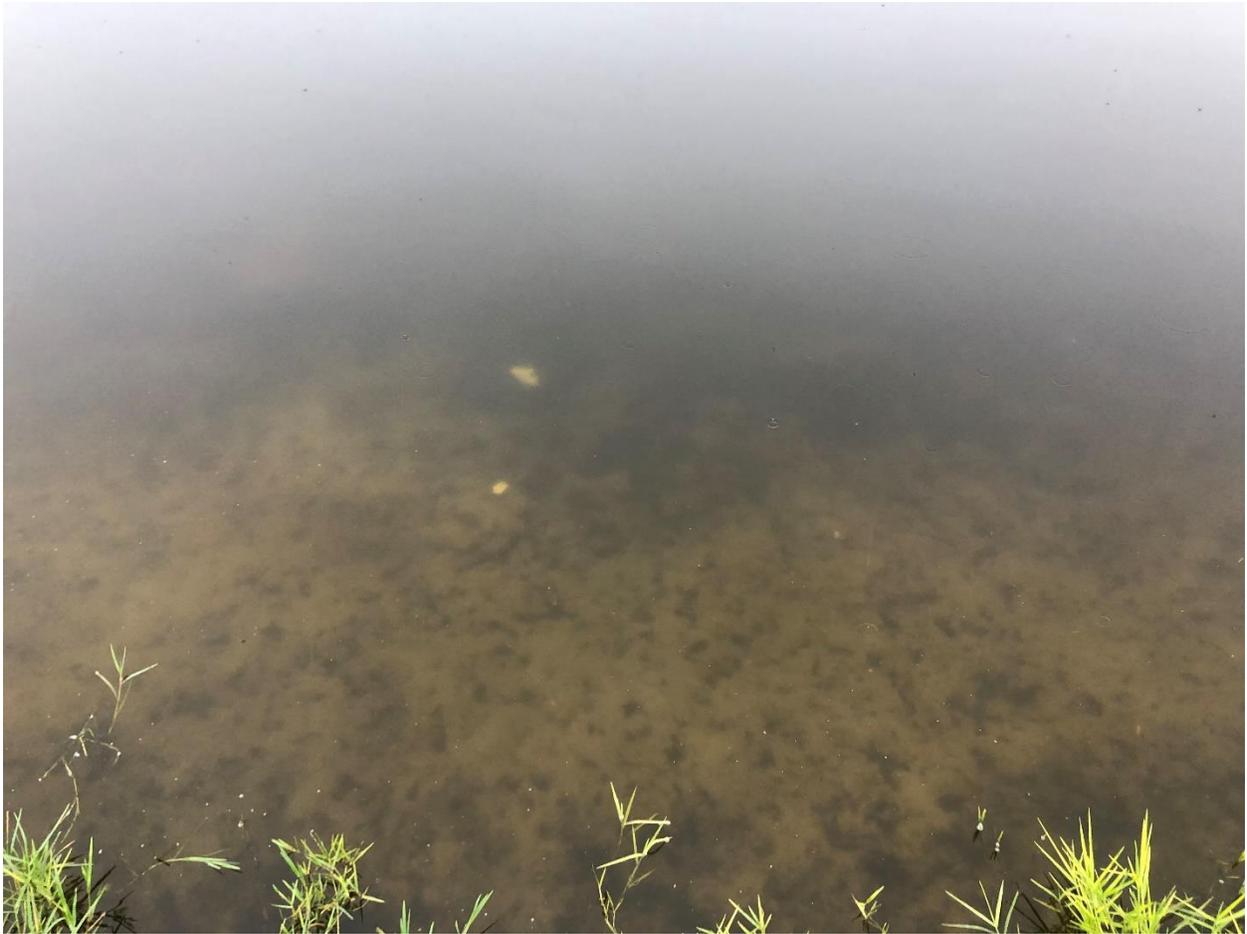
T = 0 hours to T = 19 days after treatment:

Visible golf balls – close-up view.

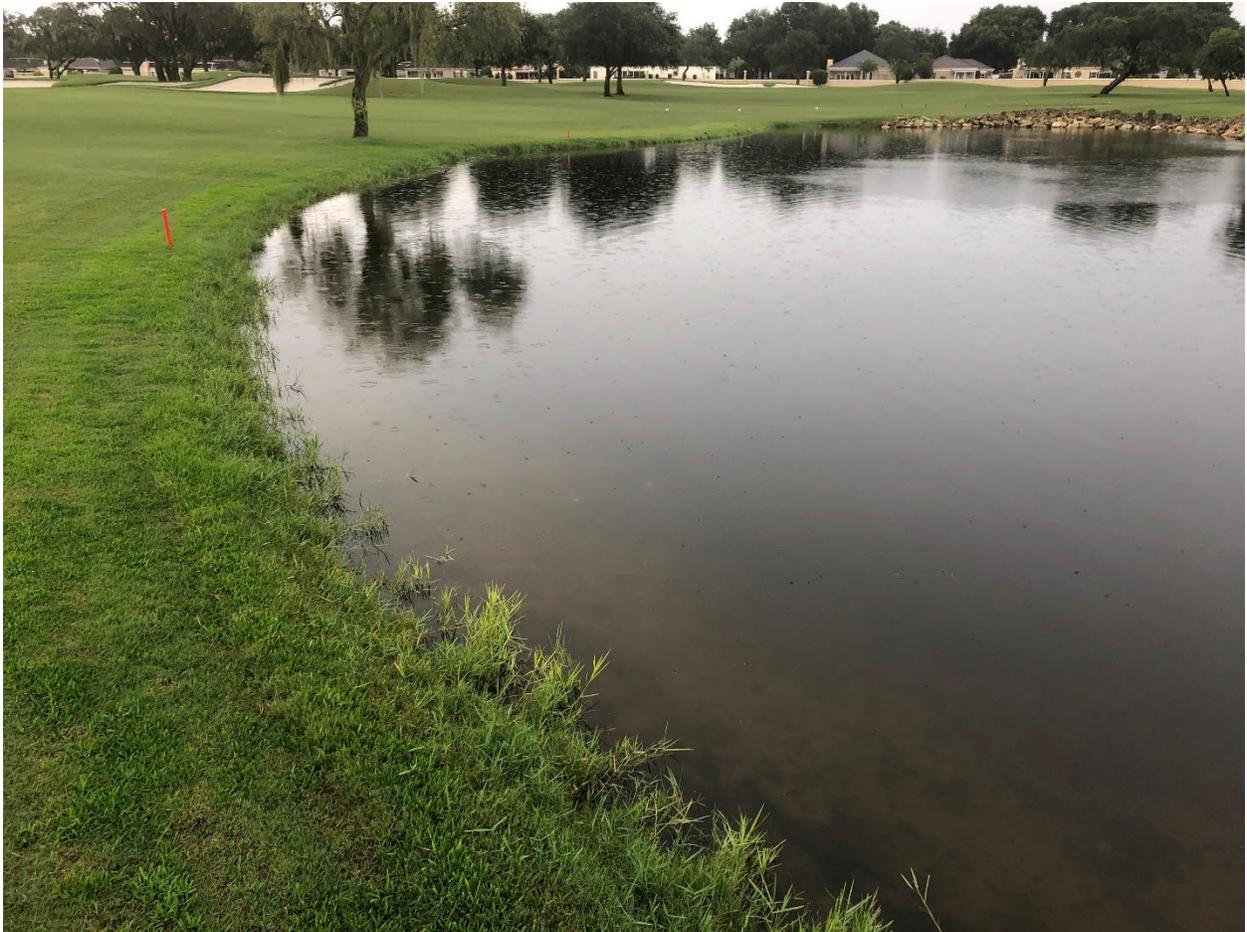
T = 0 hours to T = 19 days after treatment:

Visible golf balls – far away view.
